Catalina 350

Broken Brackets on Fuel Filter and Heat Exchanger Repairs

Five Year Maintenance and the C350 Exhaust Riser

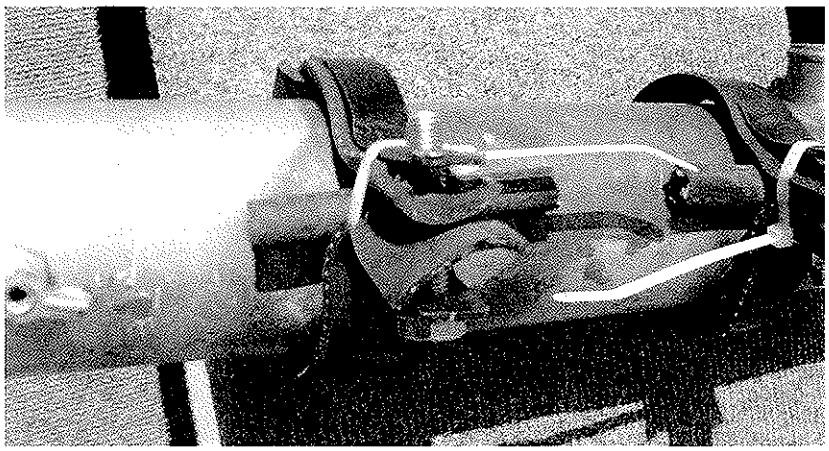
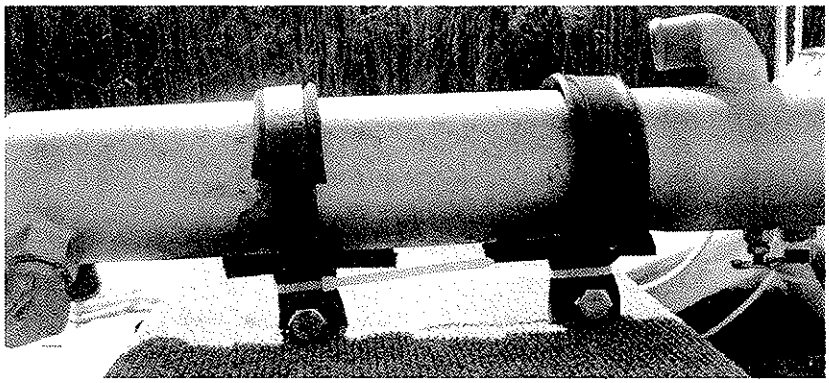
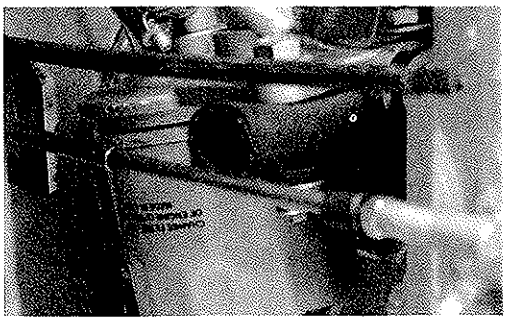
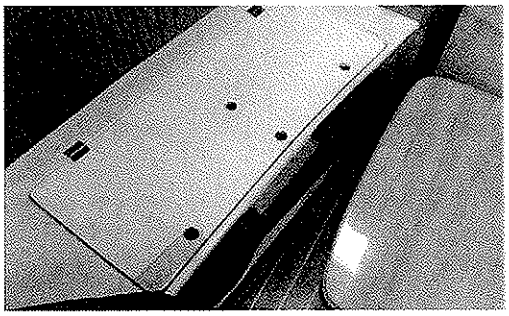
I picked up my Catalina 350 (#246) new in May of 2004. It is equipped with the standard Universal M-35 4 cylinder diesel. I use the boat regularly throughout the year in Niceville Florida (in the Panhandle) and have approximately 450 hours on the engine. Over the years, the engine has proven to be very reliable and I have had very few problems. I change the oil annually and try to do all the recommended periodic maintenance to include inspections of all the hoses, fittings, and other connections. About three years ago, I noticed that the primary/screw-on fuel filter on the starboard side of the engine was loose. The "L" bracket that held the fuel filter assembly to the engine had sheared at the 90 degree angle. The fuel lines to/from the filter were the only things holding the filer assembly in place, and were rubbing against other parts of the engine--probably not a good thing. I assumed that I just had a bad bracket and took both parts to a welder who repaired it using an extra heavy bead at the broken seam to make it a bit stronger. Inspecting the engine a few months later, I found a bolt head lying at the bottom of the containment bilge under the engine. Naturally, finding a sheared off bolt head under the engine is a bit alarming to say the least. After a lengthy search, I found that the guilty bolt head (and the rest of the bolt) had come from the newly welded fuel filter assembly bracket. The bracket was fine and the second bolt was still holding, but now the obvious problem was excessive vibrations from the engine. I had a mechanic check the engine mountings and they were all fine. Instead of just replacing the bolts, I got two longer, high quality stainless steel bolts, and a 4 inch length of 1 in. inch radiator hose. I drilled two holes thru the radiator hose to correspond to the holes with the mounting bracket and the fuel filter assembly. Then I took the two new bolts and re-mounted the fuel filter assembly, but using the radiator hose as a shock absorber between the bracket and the filter assembly. (See photo). I admit it's a "jury rig" but it appears to work fine and I haven't had a problem since. Given the discussions I've seen in 350 IA e-mails, it seems that several other boats have had the same problem. I would also venture to guess that several boats in the fleet have the problem with the broken bracket/loose fuel filter, but they don't know it yet as making sure the fuel filter is secure is probably not a routine check item. So I would recommend that anybody with about 20 minutes free time and $4 to buy the length of hose and two stainless steel bolts from Ace hardware do the same modification.

I recommend that all owners do the quick, simple and cheap fuel filter modification. I don't know what to tell you to do about the heat exchanger. My suggestion is to check the brackets at least monthly, and to do this or another mod-

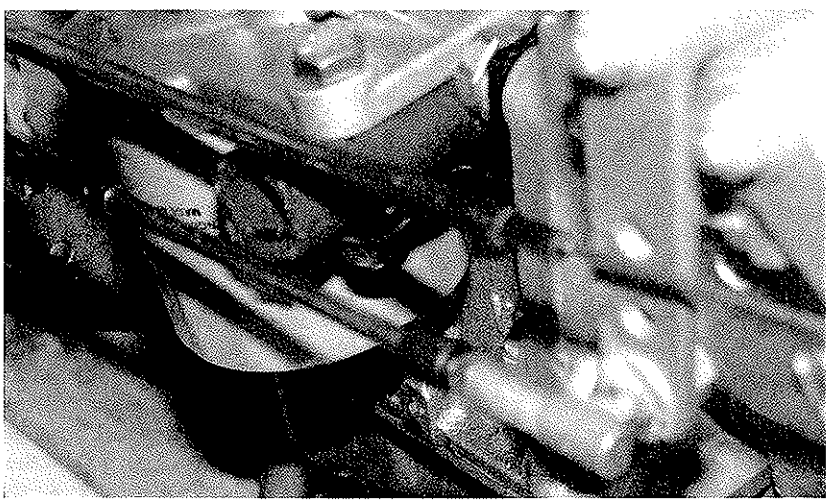
But wait...my problems with engine vibrations weren't over. Last week, when pulling into a dock with the motor in idle, I got a very rapid over temp. I cut off the engine and made it to the dock under sail. Investigating the problem, I found that I had a substantial amount of engine coolant in the containment bilge under the engine. &^%#^!#^^&$)!*!(!! I checked all the usual suspects-belt, thermostat, raw water pump, engine mounted coolant pump—even the thru hull. I couldn't find any leaks and couldn't figure out why it was overheating or how the coolant had leaked out. After many contortions in and around the engine, several skinned knuckles, and lots of cussing, I eventually tracked down the problem. The two mounting brackets for the heat exchanger (you guessed it) had broken and the heat exchanger was resting on the aft part of the engine. Eventually, the vibrating contact with the engine had worn on the bottom of the heat exchanger cylinder and opened a small crack which allowed about half the coolant to leak out before I shut down the engine. It went into the containment bilge from the aft part of the

engine which explains why I couldn't find the source.

I took the heat exchanger to the good people at the Fort Walton Beach Radiator Repair shop (in Ft Walton Beach, FL). As the heat exchanger cylinder is copper, they braised the crack and also built up other areas on the cylinder that had some wear from vibrating against the engine. Then I asked them to manufacture two new mounting brackets, but to make them a larger diameter than the originals. They had to have the same shape as the old ones so as to properly fit the heat exchanger correctly in its place behind the engine, but I wanted to wedge sections of filleted radiator hose in between the bracket and the cylinder. I also placed a small section of hose where the brackets pinched together to provide added padding for the heat exchanger. I pulled the brackets together with a large vice grip, and used plastic ties to hold them snug against the cylinder. I drilled out the part of the hose that was covering the mounting bolt holes and then threaded thru two longer high-grade stainless steel bolts to replace the shorter original mounting bolts. (see photo). While it didn't look especially pretty, my intent was to pad the brackets and to prevent metal-metal contact between the cylinder & brackets and the cylinder & engine. Then I maneuvered the cylinder back into position and after many more contortions, skinned knuckles, and lots of cussing I managed to get the bolts threaded into their mounting holes in the engine. Once the bolts began to thread in, I cut away the plastic ties.

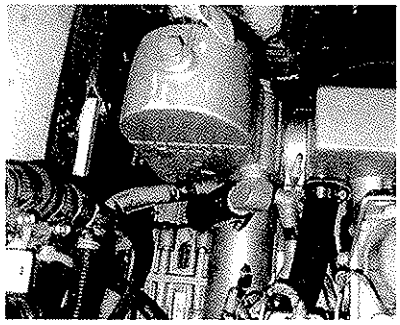
1. The clear plastic hose to the coolant expansion tank was leaking and was easily replaced with a section of heater hose (my local NAPA auto parts store had the right size, which I believe, was 5/16-inches).

2. The 7/8-inch raw water hose from the heat exchanger to the raw water pump (runs along the port side of the engine) had several areas of abrasion and was replaced. I noted that this hose was about five inches longer than what is recommended in the manual so I replaced it with the correct 26-inch length allowing for a better fit and minimal chafing potential. While I was at it, I also replaced the short 11-inch section of 1 1/8-inch hose carrying coolant from the exhaust manifold to the top of the heat exchanger.

3. The hose running from the heat exchanger to the fresh water pump adjacent to the long raw water hose described above, had just about worn through in several spots. This was caused by contact with the improper length raw water hose. This is an expensive custom shape hose (over $40 – Universal part no. 200439) which now fits much better with the correct sized adjacent raw water hose.

4. The heat exchanger had considerable deposits in it, although not to the point it caused an increase in engine operating temperature. It passed the pressure testing with no problems and should probably serve well for the next five years.

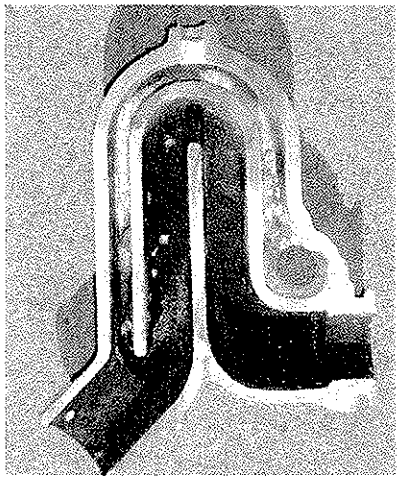
To verify my hypothesis regarding the observed localized corrosion deposits in the exhaust passage of the exhaust riser, I cut the riser in half to do a forensic inspection. I was very pleased to see that the aluminum wall between the seawater passage and the exhaust passage is very thick. This verified my hypothesis that the few localized areas of corrosion in the exhaust passage were not caused by leaking from the sea water side of the riser, but instead were likely due to condensation. I also considered the possibility of seawater sloshing up the exhaust passage and through the riser. However, if this had occurred, seawater would have pooled at the bottom of the exhaust passage, which is slightly lower than the exhaust manifold flange, and there would be considerable corrosion at the low spot. The absence of significant corrosion at this point is evidence that no seawater had sloshed up and through the riser exhaust passage. Additionally, I found that the riser provides about 5-inches of rise above the entrance to the exhaust manifold, essentially adding 5-inches of vertical distance that seawater within the exhaust system would have to travel before it could enter the engine.

Once the riser was opened up, I observed some apparent thinning (but still very thick) of the aluminum wall on the lower portion of the seawater inlet (note that I scraped away a considerable amount of material prior to taking the photo). I also noted that there was some corrosion or deposits in the seawater passage which if allowed to progress, would eventually restrict the flow of water through the riser. Based on this observation, I believe it is more likely

that the riser would start to cause problems due to blockage in the seawater passage (most likely overheating) before the wall between the seawater and exhaust passages corrodes through. This is good news as the later could result in catastrophic engine failure. Regardless, I believe a five-year replacement schedule for the exhaust riser is probably good insurance and the job is not that difficult.
