Catalina 350

C350 Association Technical Editor
Skip Penizotto
703 Willowmere Lane
Ambler, PA 19002
(215) 654-9950
skip7@verizon.net

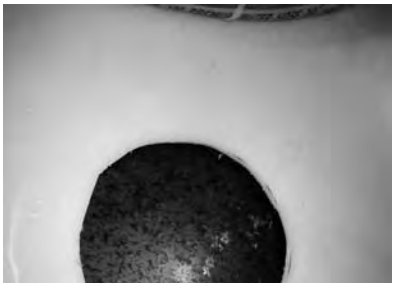
Cutting the hole in the salon water tank
