Catalina 350

Fresh Water Flush To Resolve Smelly Head Problems

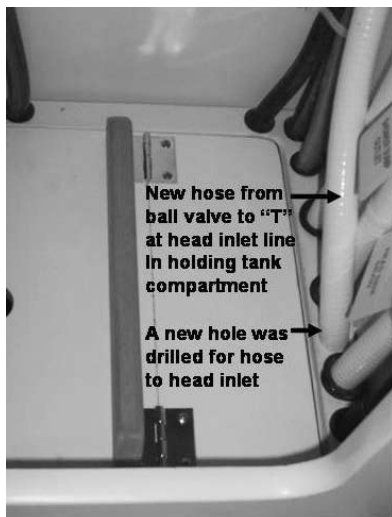
This modification was accomplished by inserting a tee fitting in the sink drain hose and another tee in the head inlet hose near the filter in the holding tank compartment. I ran a hose between

the tees with a ball valve installed near the sink drain tee. The sink drain tee is mounted up high to be above the waterline as my personal preference is to minimize below waterline fittings. I also modified the cover plate in the bottom

of the vanity cabinet to allow easier access to the sink drain and shower drain seacocks. One hint in doing this project is to use a lubricant when putting the hoses on the tee and ball valve fittings (I soaked the hose ends in hot water and then used dishwashing soap).
